ATTACHMENTS EXCLUDED FROM AGENDA ORDINARY COUNCIL MEETING 27 JULY 2023

CCL23/202 Growing Regions Program Round 1 - Expressions of Interest

Dubbo Regional Council – Flood Response 2022 Priority Site Summary – Site 4 – Sandy Beach – Dubbo NSW

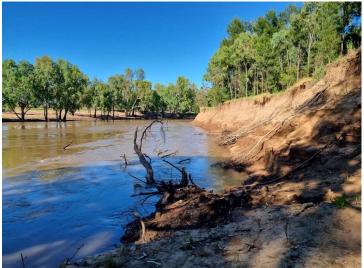
- Steep to near-vertical banks are still present in Section DMR_R28 and exhibit vertically
 accreted sandy silt sediments above the water level at the time of the inspection (Photo 1).

Photo 1: DMR_R 28 - During site inspection, water levels were still elevated.

To address the bank instability, DRC should consider and implement bank stabilisation works consisting of either a series of 8 log deflector structures or provision of a rock protected, lower bank bench with 3 to 4 embedded log deflectors.

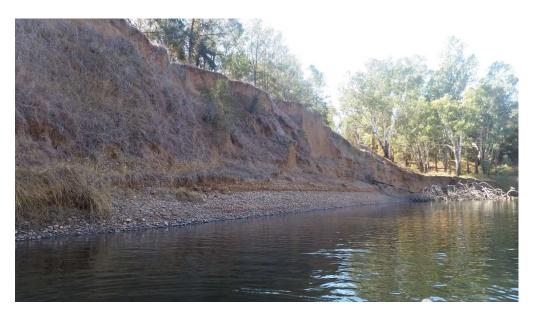
- Recent erosion of the bank was evident at the time of the inspection, with freshly fallen saplings lying on the bank.
- The 2018 assessment was undertaken at time of lower flow levels and identified a gravel/cobble layer exists along the lower approximate 1 metre of the bank profile (Photo 2). This layer has a gentler grade than the overlying sandy silt sediments, indicating that the gravel layer is more erosion resistant. This affords some stability to the toe of the bank and may limit the overall rate of bank retreat.

Photo 2: DMR_R 28 – During site inspection in 2018 displaying gravel/cobble layers in bank toe.
