# **PLANNING AND DEVELOPMENT COMMITTEE**

PDC17/24 Planning Proposal (R15-3) - Proposed  
Alteration to Minimum Lot Sizes Lot 172 DP 753233,  
20R Peak Hill Road, Dubbo

# PLANNING PROPOSAL

## AMENDMENTS TO THE MINIMUM LOT SIZE WITHIN THE SOUTH WEST PRECINCT HIGHVIEW ESTATE

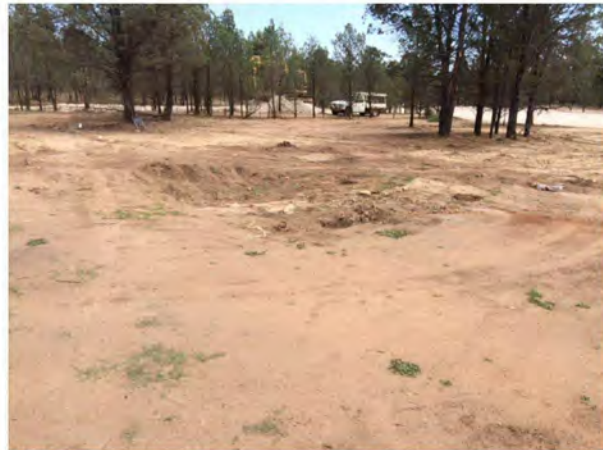
West across footprints of Stockpiles, D, E and F

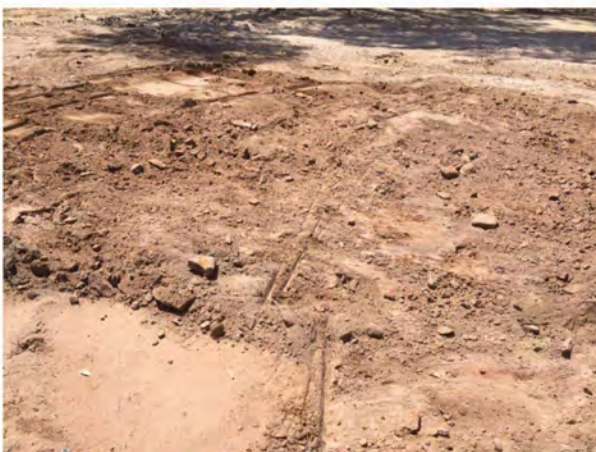
North west across hydrocarbon staining excavation pit

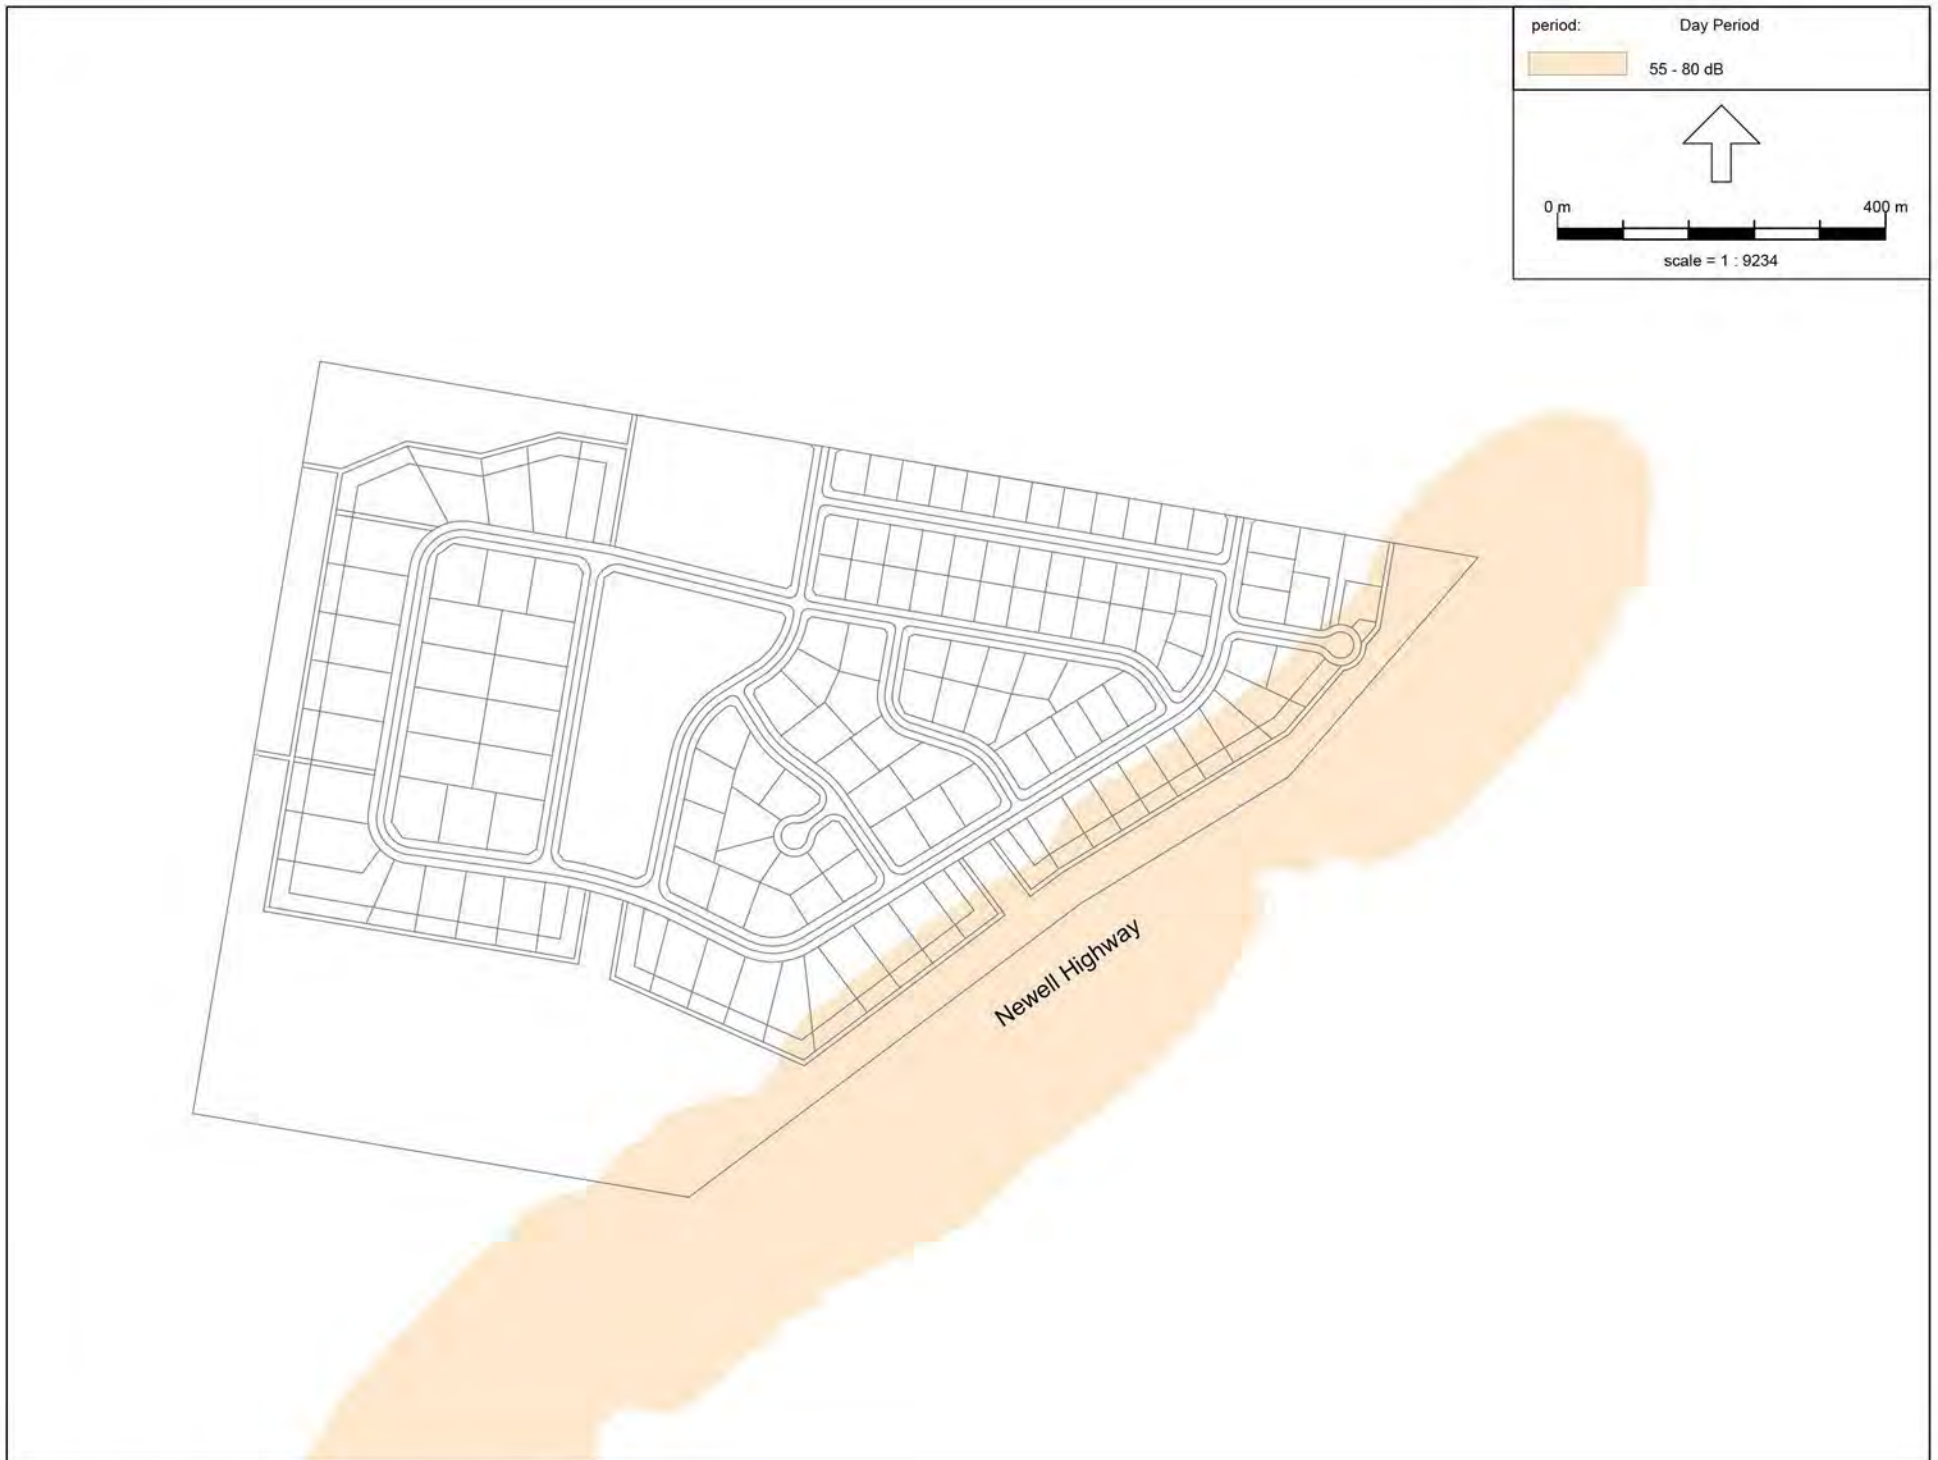
Figure 6.1 Kintyre Stage 2 - Scenario 1, Mitigation Zone for Building Treatment Category 2.

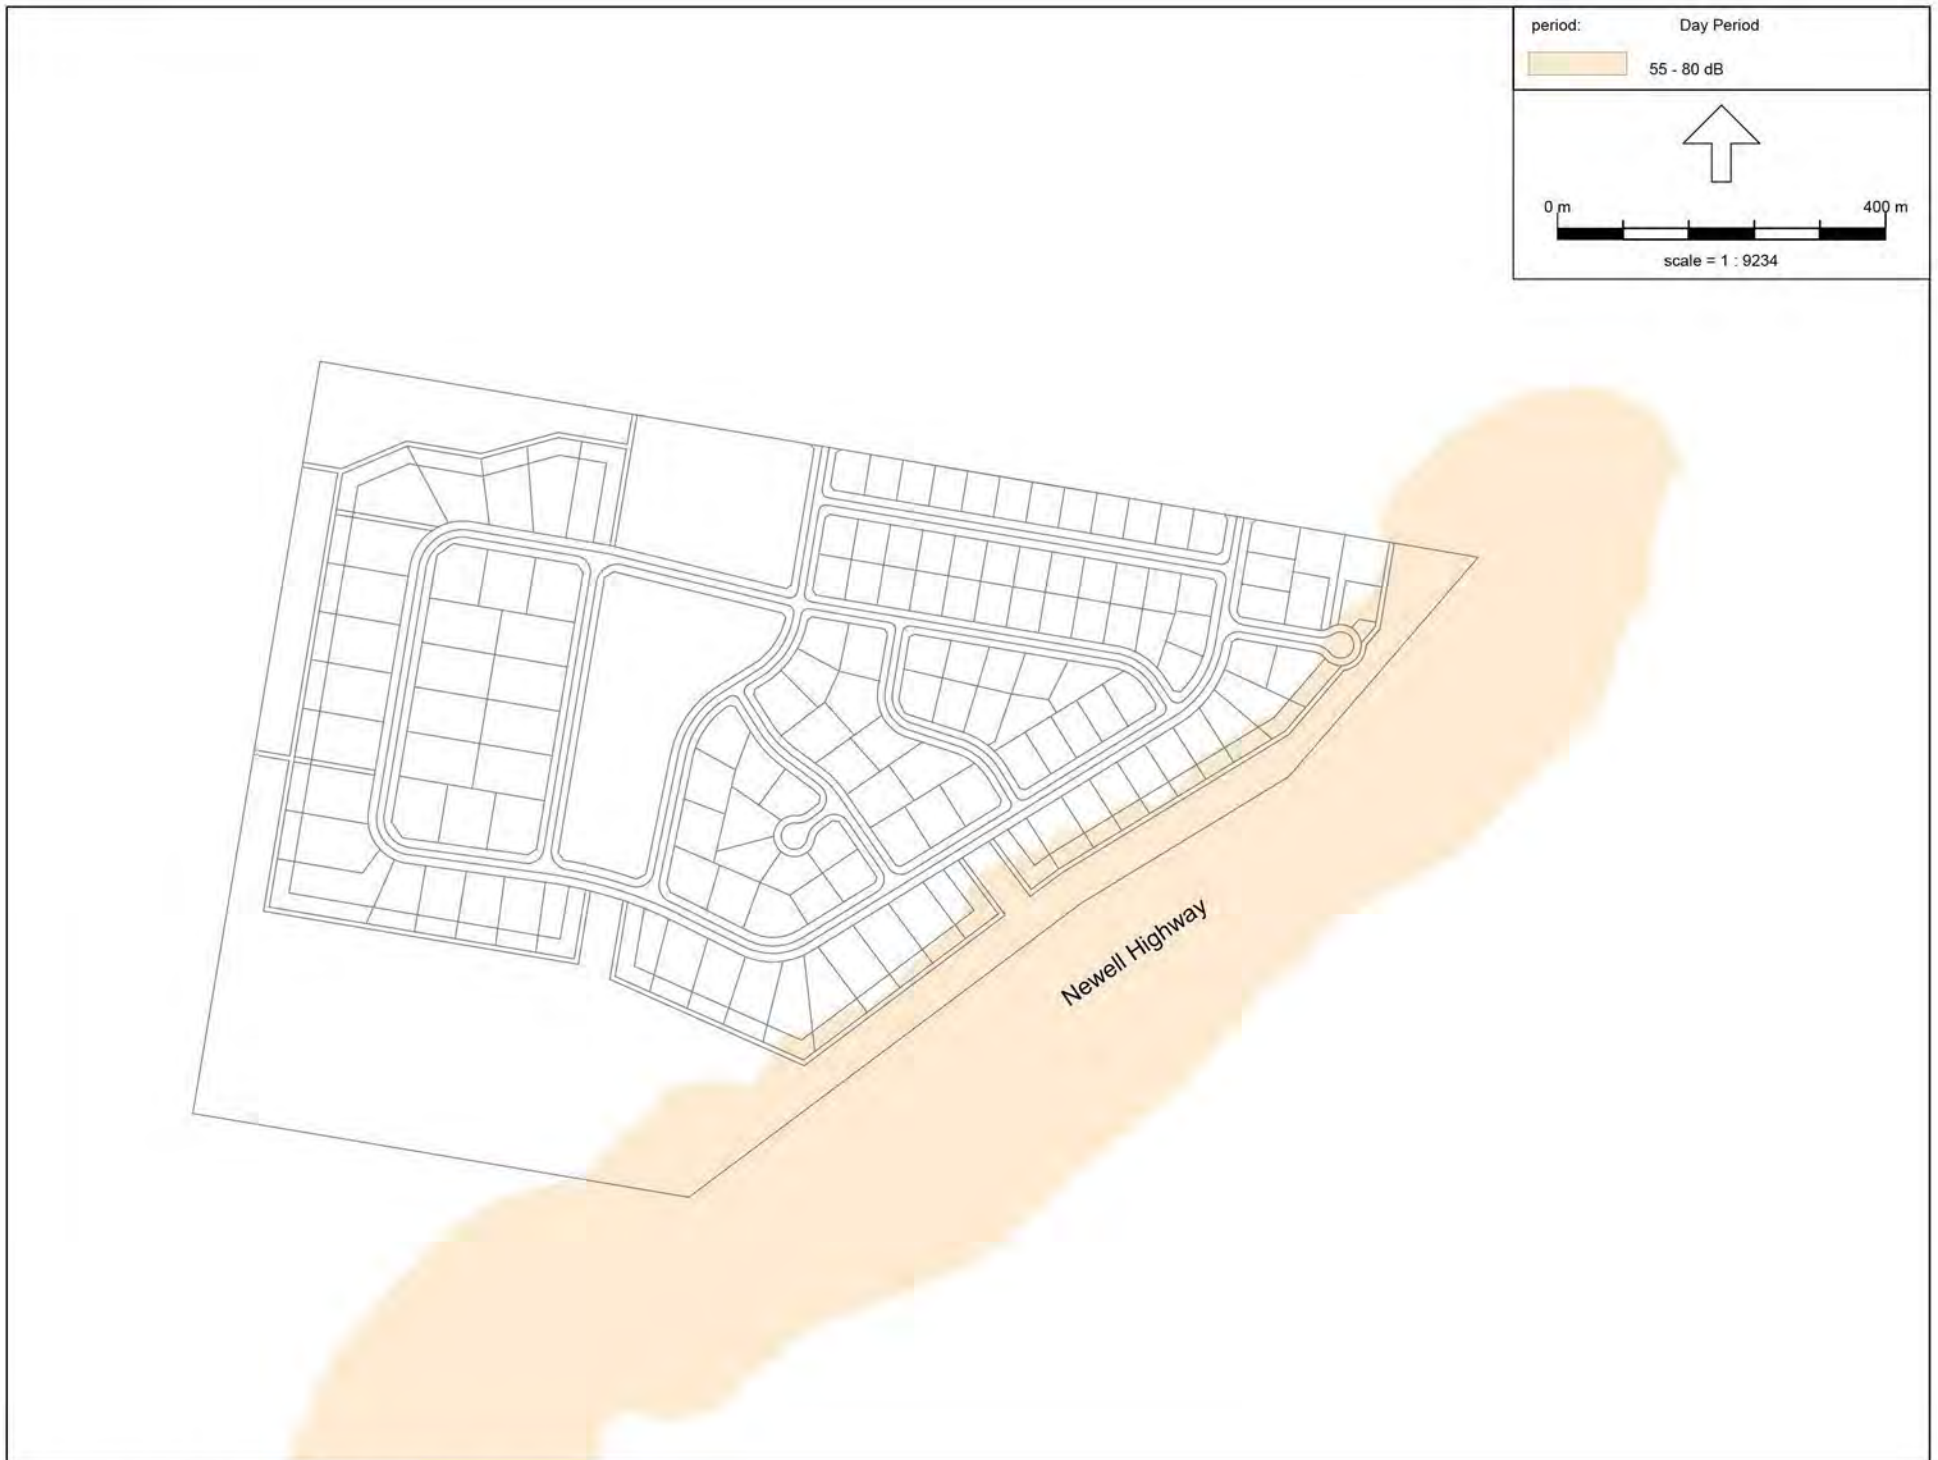
Figure 6.2 Kintyre Stage 2 - Scenario 2, Mitigation Zone for Building Treatment Category 2.
