# **2026 - 2036**

## PUBLIC AMENITIES STRATEGY

## Executive summary

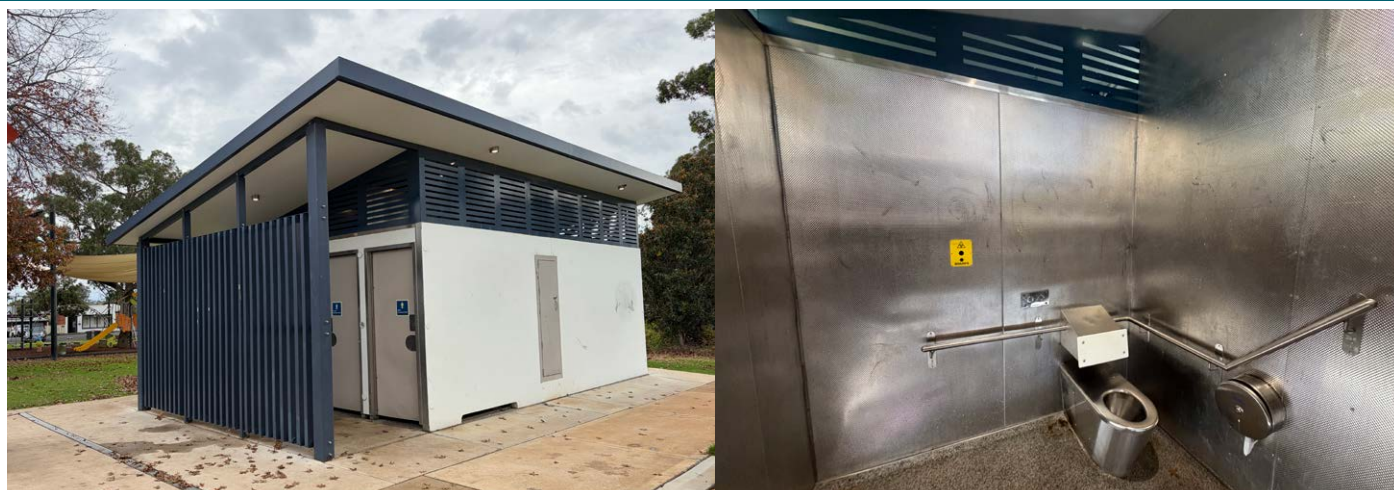
**Site Description:** Elston Park is a small, well maintained district park. It has active frontages on three sides, comprises tennis courts, a bridge club, splash park, and a disused amenities block while a network of paths provides good overall accessibility. The amenities block also houses the electrical switchboard for the Elston Park Bore and the filtration system for the splash park. Elston Park is an attractive green space with large areas of well-maintained lawns interspersed with trees which afford good visibility throughout the site except for one small area between the amenities block and the tennis courts where the landscaping is overgrown and provides a sense of enclosure. The site around the amenities block offers the splash park facility, BBQs, a bubbler, picnic tables and shade cloths lending itself to families with smaller children.

**Building description:** The well-designed amenities consists of three individual cubicles one for men, one for women and one for unisex with a transparent privacy screen. They are located some distance into the park making them susceptible to vandalism and are accessible via a ramp and path from Gipps Street. There is good quality natural light and ventilation throughout. The amenities block itself features large sections of blank wall making them susceptible to graffiti.

**Condition assessment:** Inspections identify a low incidence of major defects and a typical incidence of minor defects to both internal, external and roofing fixtures. The overall condition of the building is rated as *above average*.

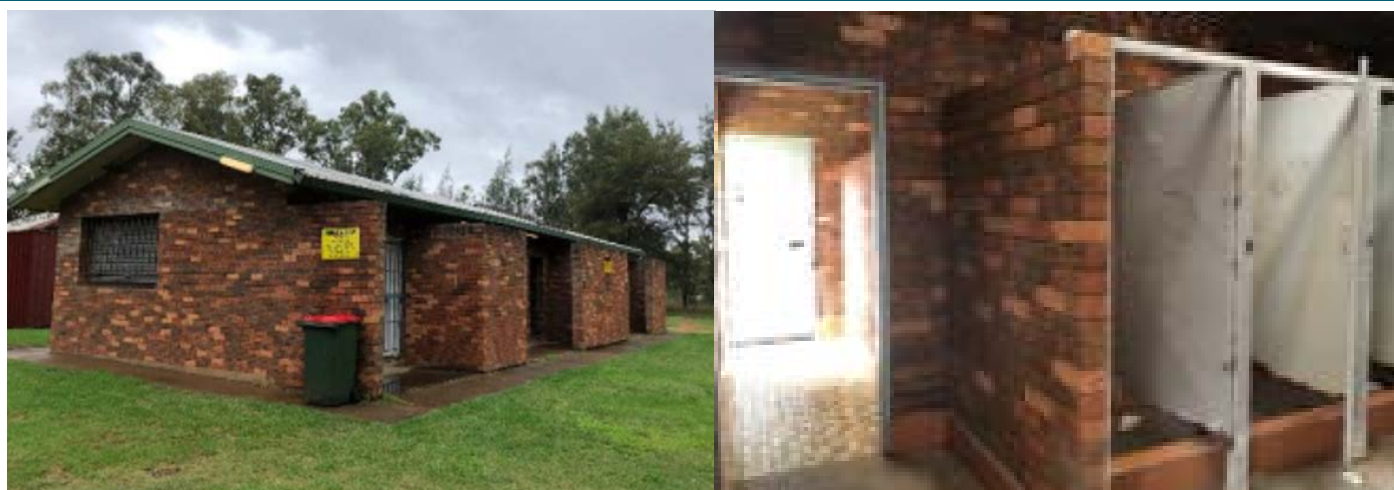
## Sandy Beach, Dubbo

**Site Description:** Sandy Beach Reserve amenities are situated at the top of a lawn that slopes down to the river beside a carpark. The wider area is surrounded by bushland, minor roads and walking trails and as the name suggests in an attractive area of sandy beach to support river swimming. While the building is well maintained and in reasonably good condition this facility is a more isolated location. A masterplan exists for the wider river precinct.

**Building description:** The amenities are a large brick building with maze style entry that does not conform to CPTED principles. The facility is entered by men and women at different ends of the building. Entering a communal space in an isolated area where there is little activity may compromise a user's sense of safety and security, particularly as this building includes both toilet and the only hot water public shower facilities in the city. The building is well maintained and clean.

**Condition assessment:** Inspections identify a high incidence of major and minor defects to both internal, external and roofing fixtures. Interior fixtures and linings of the building were in poor condition, and it is recommended they are removed and replaced to prevent further defects. The overall condition of the building is rated as *below average*.

1. Redevelop the Sandy Beach amenities as per the wider master plan for development of the site, in consultation with key stakeholders.
2. If refurbishment is planned, consider reconfiguring to outward facing accessible cubicles to remove internal space and assess requirement for public showers.

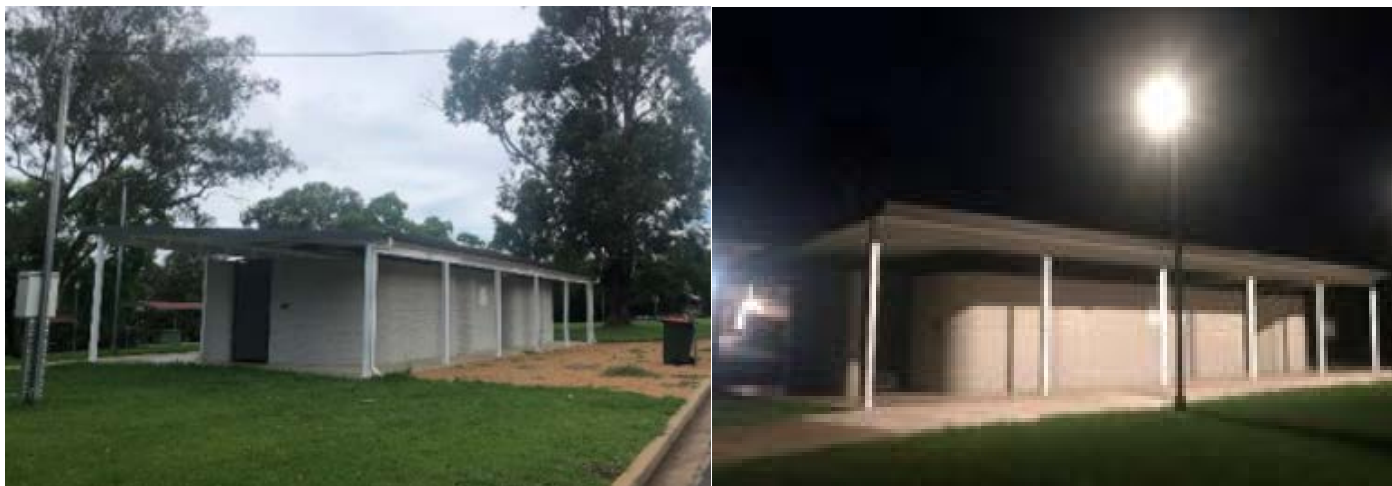
## Lions Park West, Dubbo

**Site Description:** Lions Park West amenities block is located on the southern side of the river along a popular cycling and pedestrian pathway. The surrounding area contains a local playground, boat ramp, seating and BBQ areas.

**Building description:** The amenities are a 3D printer designed facility constructed of a unique material known as Contour-Crete. Men's and Women's entrances are separated at either end of the facility. The internal communal area is spacious with good quality natural light and ventilation. The amenities require addition of a ramp or pathway from the street to increase accessibility from the street at the rear of the facility.

**Condition assessment:** Inspections identify a typical incidence of major and minor defects to both internal, external and roofing fixtures. The overall condition of the building is rated as *average*.

Improve accessibility of the building by provision of a ramp or pathway from Beni Street to the entrance.

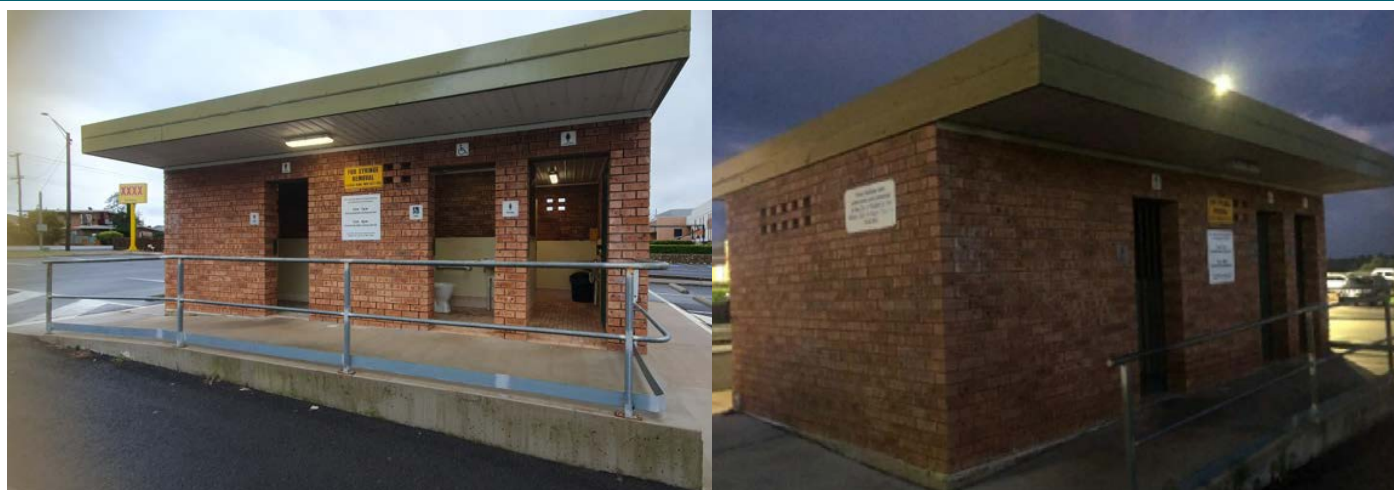
## Sir Roden Cutler Park, Dubbo

**Site Description:** The facility at Sir Roden Cutler park is situated on the edge of the reserve in the carpark of 'Club Dubbo' along the busy highway. The location is such that patrons attending the club can park surrounding the amenities block in formalised marked spaces. Whilst located in the carpark of the privately owned facility, the amenities are intended to serve the large reserve which continues to the riverfront down a steep slope. The park features BBQs and picnic areas, a ninja obstacle course and large open turfed space.

**Building description:** The small brick amenities were opened in 1993. The facility is in average condition, featuring separate men's, women's and accessible external entrances. The facility is accessible with a paved entry and disabled carparking spot located close by, however the internal fittings and fixtures do not comply with current accessibility standards. The building is located some distance from parts of the open space.

**Condition assessment:** Inspections identify a typical incidence of major and minor defects to both internal, external and roofing fixtures. The plumbing fixtures throughout the building were in poor condition and recommended to be removed and replaced. The roof sheeting is rusted, with a life expectancy of 1-3 years. The overall condition of the building is rated as *average*.

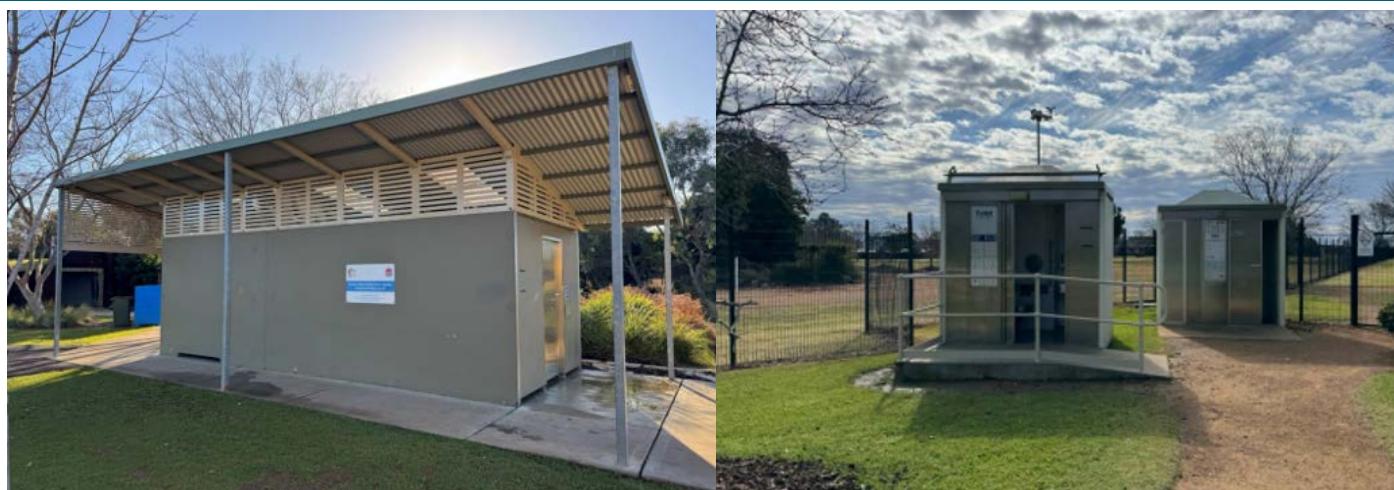
## Dubbo Regional Botanical Gardens, Dubbo

**Site Description:** The botanical gardens precinct hosts two separate amenities. Located in the Shoyoen Japanese Gardens and in the Adventure Playground. The precinct is an attractive high quality regional destination for both locals and tourists. The facilities hosted in the Shoyoen Japanese gardens are set amongst manicured lawns, landscaping and a large pond. The Adventure Playground facilities are located in a central location with the large, enclosed play space. The future masterplan for the facility includes an additional multicultural garden and the Wiradjuri Tourism Experience.

**Building description:** The Shoyoen Japanese Gardens amenities consist of two single unit modern unisex automated buildings accessible via a wide even path. The stainless-steel finishes ensure they are vandal proof. The Adventure Playground hosts a large contemporary toilet facility with a unisex and ambulant cubicle with external facing entries and communal handwashing facilities. In addition, an adult changing facility is available via separate entry. The building is designed with good ventilation and natural light, with vandal proof finishes.

**Condition assessment:** Inspections identify a low and typical incidence of major and minor defects to both internal, external and roofing fixtures. The overall condition of the buildings is rated as above *average*.

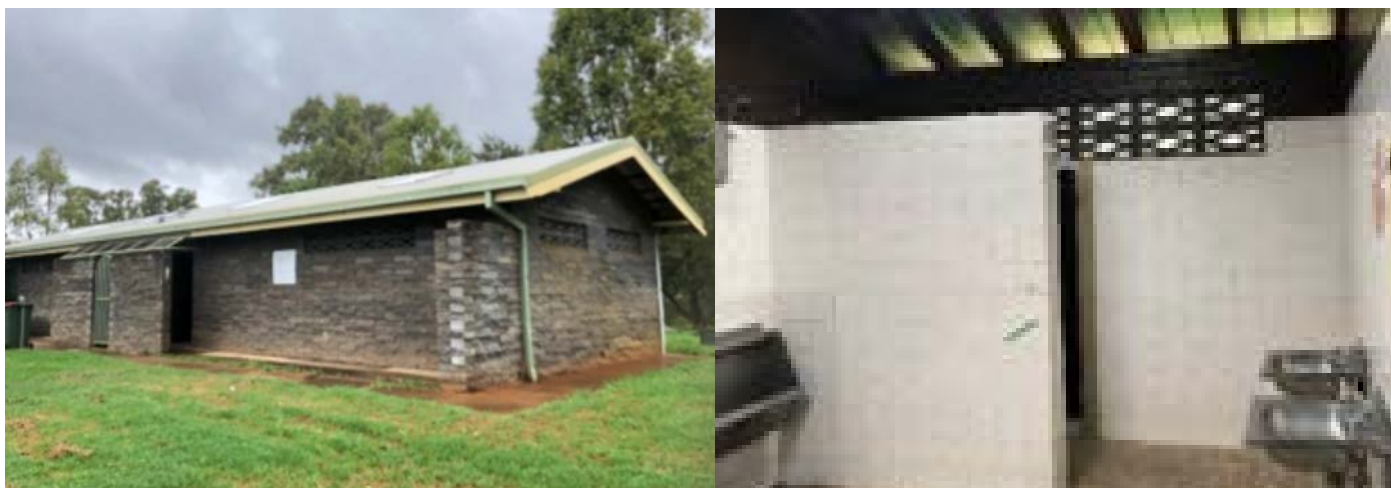
## Ollie Robins Oval, Dubbo

**Site Description:** Ollie Robbins Oval is located along the banks of the Macquarie River, close to a local shopping precinct and the main street of Dubbo. The parkland is close to sporting grounds, the Tracker Riley Promenade and a large expanse of open space which is often utilised for events.

**Building description:** The public amenities building is a large traditional brick building within an open turf space, close to a small off-road carpark. The building lacks accessibility with no formalised paths to the entry and no accessible cubicles present. The building has maze style entries with an internal shared space, decreasing feeling of safety. The building itself is in poor condition and is close to end of life. The building design includes change facilities which are not required at this location.

**Condition assessment:** Inspections identify a typical incidence of major defects and a high incidence of minor defects to both internal, external and roofing fixtures. The interior tiling throughout and plumbing fixtures are advised to be replaced, and the plumbing pipes have a life expectancy of approximately 2-5 years. The overall condition of the building is rated as *below average*.

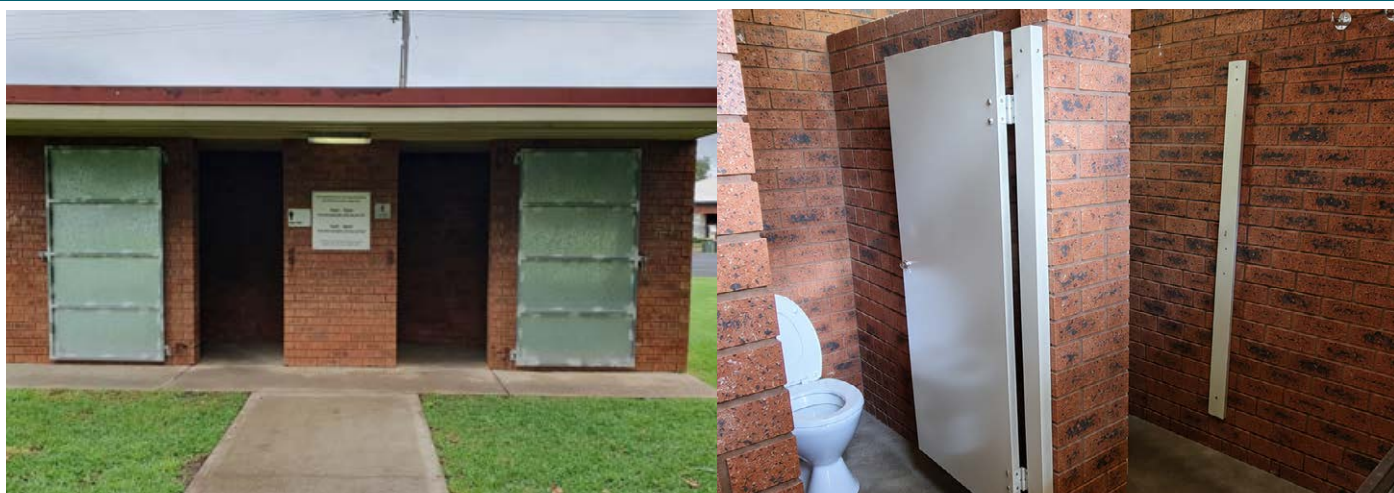
## Wahroonga Park, Dubbo

**Site Description:** Wahroonga Park is a popular local suburban park with large sections of maintained turf, established trees, a recently updated playground and well-connected pathways. The park has road frontages on all sides with clear sight lines to the amenity's facility. There are multiple BBQ facilities and large seating areas, making it popular for parties and gatherings.

**Building description:** The Wahroonga Park facilities are a traditional accessible brick building with side-by-side male and female entrances. Internal maze entries and communal space decreases feelings of safety in the facility. The facility lacks accessibility with no identified accessible cubicle, and access from the roadside limited.

**Condition assessment:** Inspections identify a typical incidence of major defects and a high incidence of minor defects to both internal, external and roofing fixtures. The interior tiling throughout and plumbing fixtures are advised to be replaced, and the plumbing pipes have a life expectancy of approximately 1-5 years. The overall condition of the building is rated as *below average*.

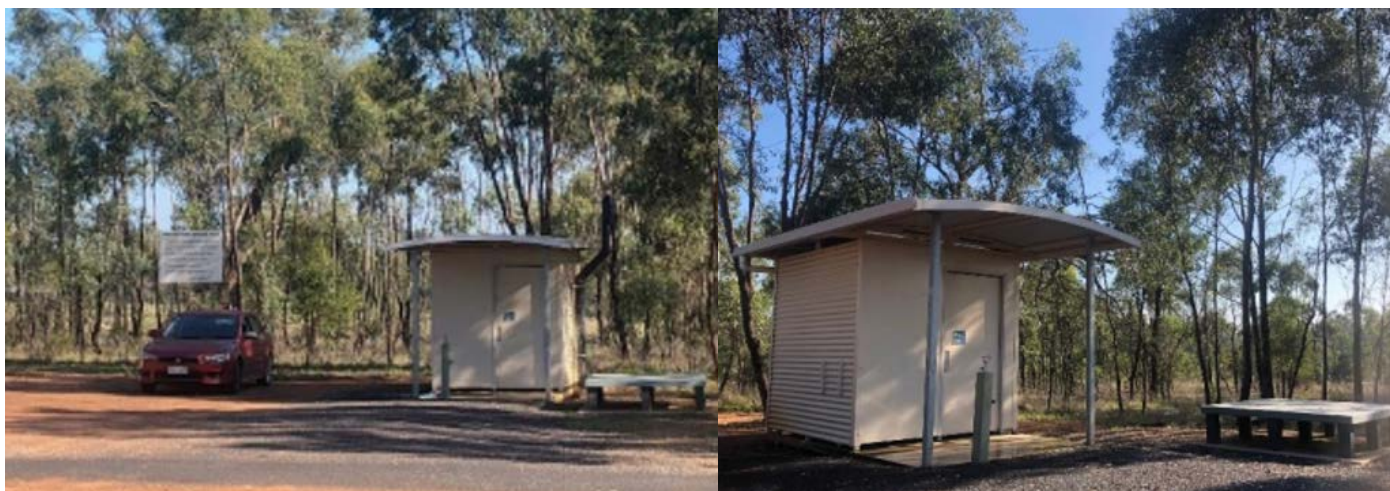
## Dundullimal Reserve, Dubbo

**Site Description:** Dundullimal Reserve is located along the Tracker Riley Cycleway, featuring an off-road mountain bike track, which is heavily used by the community. The location is within a small carpark and bushland between Taronga Western Plains Zoo and Dundullimal Homestead, featuring a water station and seating, with plenty of passing traffic.

**Building description:** The single unit unisex accessible facility is made of vandal proof materials, including corrugated iron and timber. The facility is designed to allow for natural light and ventilation, with a composting toilet. Whilst there are good sight lines to the facility, the facility is geographically quite isolated, which may allow for vandalism and graffiti.

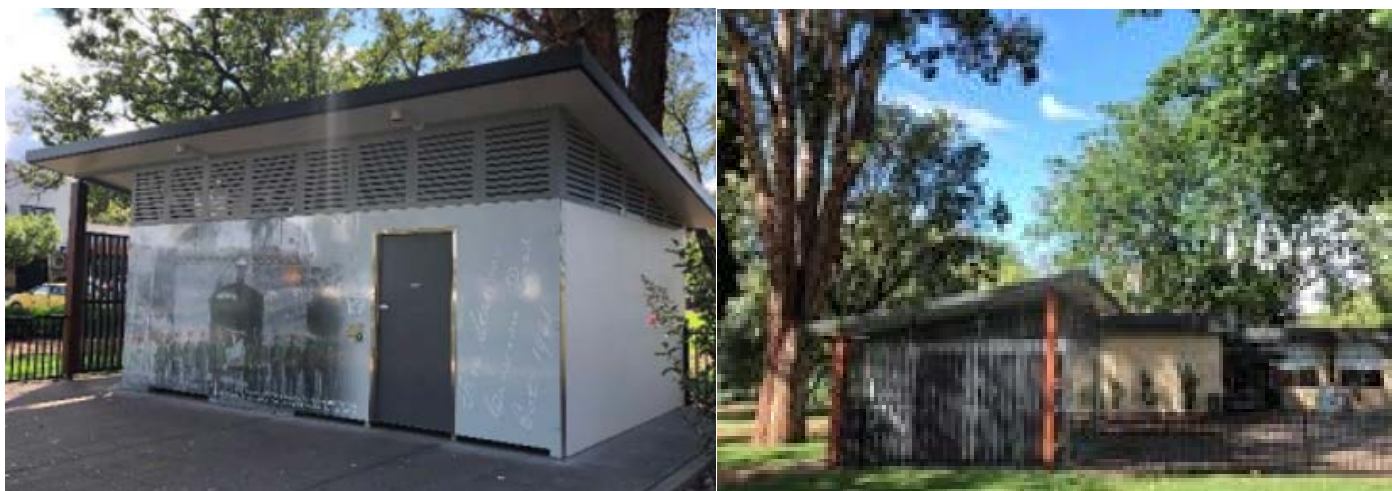
## Cameron Park, Wellington

**Site Description:** Cameron Park is centrally located within the CBD of Wellington on the Mitchell Highway. The facilities were renewed in 2019, with the new site include a large regional playground, new amenities and café building. The location of the facilities is behind a small, fenced area within the play and park area and are used by both locals visiting and travellers stopping along the highway.

**Building description:** The amenities within Cameron Park offer individual cubicles with communal handwashing and sight screens for male, female, unisex and people with a disability. The facilities include stainless steel vandal proof fittings, is well positioned with good use of natural light and ventilation. The clean, safe and inclusive facility is well utilised and meets all CPTED principles.

**Condition assessment:** Inspections identify a typical incidence of major and minor defects to both internal, external and roofing fixtures. The overall condition of the building is rated as *average*.

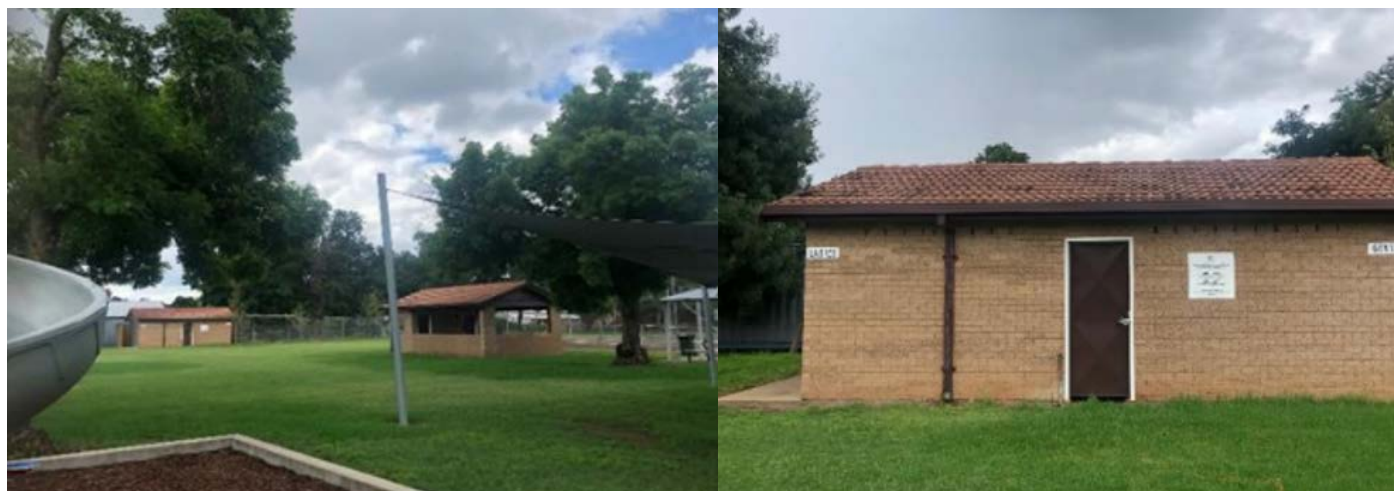
## Teamsters Park, Wellington

**Site Description:** Teamsters Park is a small local park with an amenity building, tennis courts, a playground and shaded seating. The amenities are poorly located and isolated toward the rear of the park without clear sight lines and a distance from all feature elements of the park and the road.

**Building description:** The Teamsters Park amenities is a traditional brick building, with maze style entry into a communal area, reducing feelings of safety. Male and Female entry points are at either end of the building, with artificial light and poor ventilation. The accessibility of the facility is limited with no formalised pathways through the park and no dedicated accessible toilet facility.

**Condition assessment:** Inspections identify a typical incidence of major defects and a high incidence of minor defects to both internal, external and roofing fixtures. There are holes in ceiling and eaves which should be tested for asbestos. The overall condition of the building is rated as *below average*.

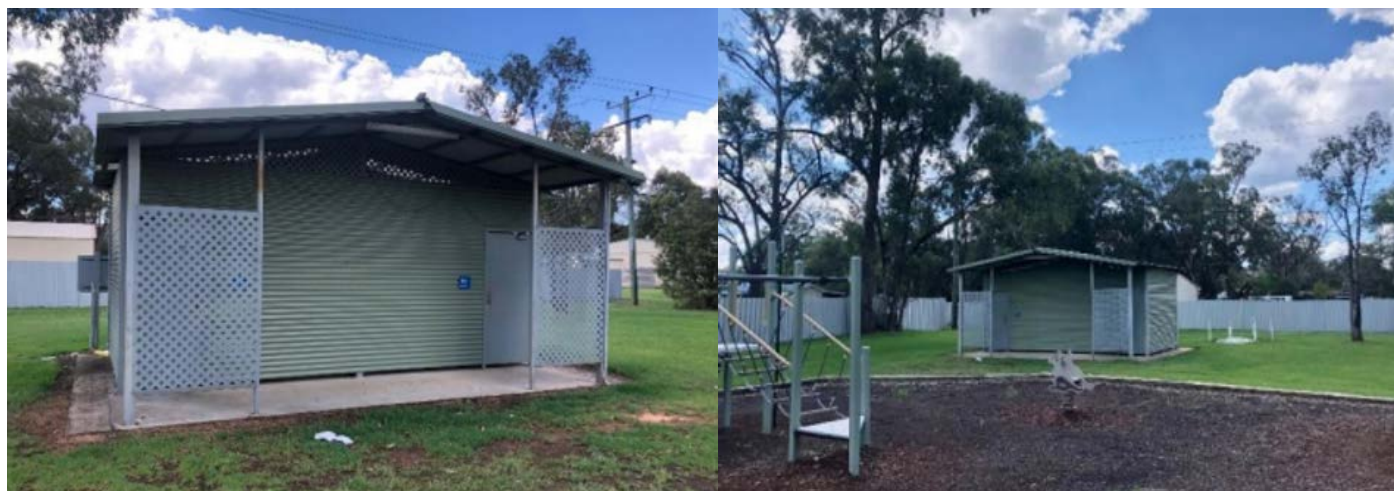
## Thelma Pelosi, Ballimore

**Site Description:** Thelma Pelosi Park is located within the main street of Ballimore. The site is an open green space with children's playground, picnic table and bbq facilities. The amenities block is situated towards the back of the site behind the playground, making access difficult. There are no formalised paths to the entry of the facility.

**Building description:** The park facilities are functional and modern, with male and female entries at either end of the building. The entries, whilst maze style, are protected by a lattice style privacy screen. The corrugated iron and timber building is well maintained and reasonably vandal proof. The facility is not accessibility compliant.

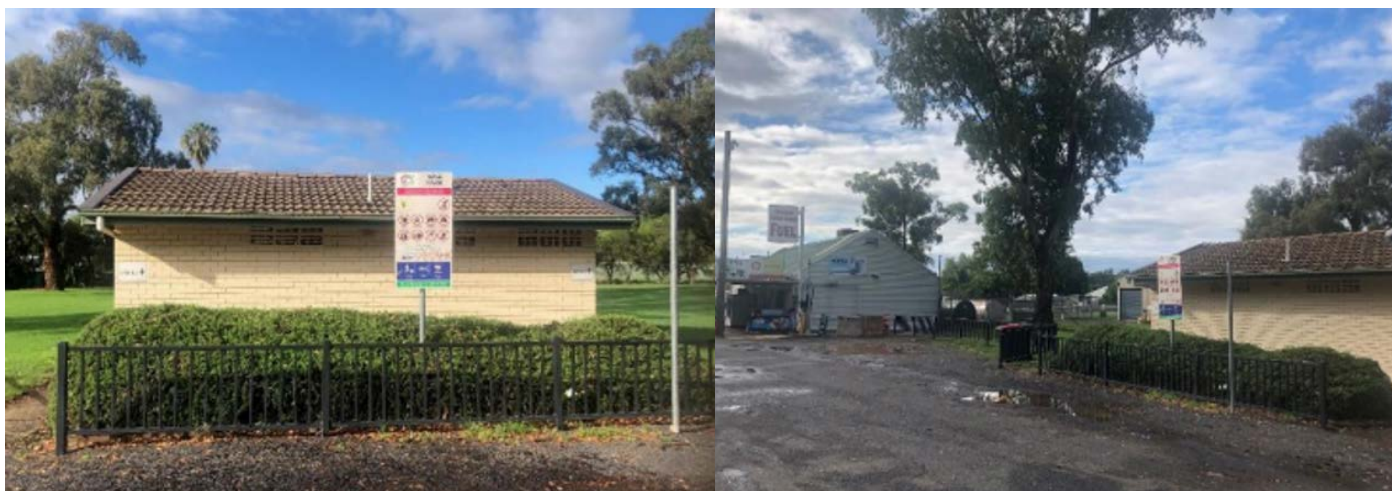
## Wise Park, Geurie

**Site Description:** Wise Park amenities are located along the main highway between Dubbo and Wellington in the village of Geurie. The amenities are popular for tourists and locals travelling between towns, as well as local pedestrians. The amenities are located along the road edge of a large open green space with picnic tables and a small fence along its frontage. The park is often used for local markets and events.

**Building description:** Wise Park amenities are an older brick style building with a tiled roof. The traditional style facilities have male and female entries at either end of the building. Users enter into a communal space for hand washing, with three internal cubicles present. The amenities are in reasonable condition, with an internal accessible cubicle, however accessibility from the road to the facility could be improved. There is a reliance on artificial light within the facility, with ventilation limited.

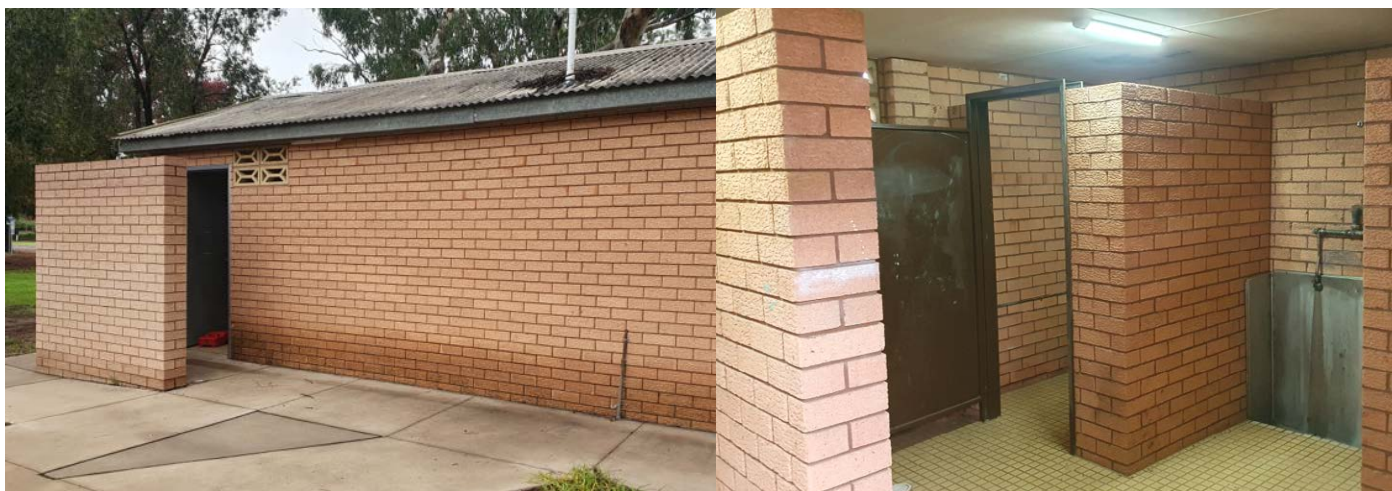
## Tom Culkin Park, Geurie

**Site Description:** Tom Culkin Park is located within the small village of Geurie, next to the main sporting ground for the population. The park includes a children's playground, skate park, tennis courts, picnic tables and plenty of established shade trees. The amenities service both local park users, and users of the adjacent sporting ground.

**Building description:** The amenities is a traditional brick building with a corrugated iron roof, with maze style male and female entry points at either end of the facility. The orientation of the building faces inwards towards the park, reducing visibility of entry points from casual surveillance. Patrons enter the facility into a communal hand-washing space, with individual cubicles. The facilities are in good condition, however, do not comply with current accessibility standards. There is one formalised entry path to the facility which does not connect to the rest of the park, and the location of the facility is not practical for the orientation of the park.

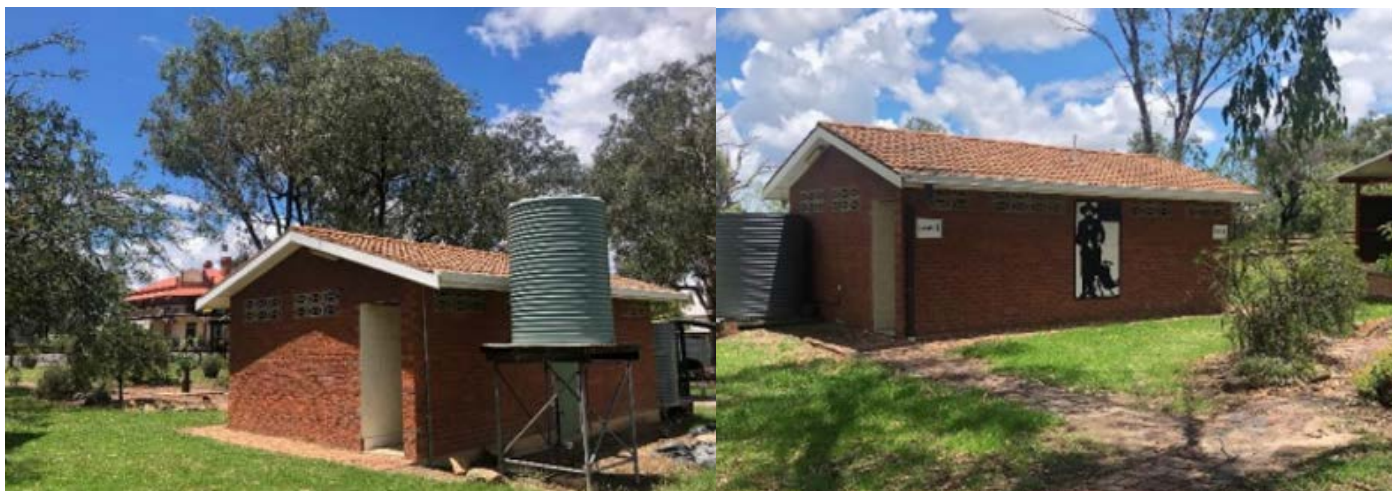
## Moxon Park, Stuart Town

**Site Description:** Moxon Park is centrally located on the Main St of the small town located approximately one hour from Dubbo. The amenities are located towards the back of the park, which features a child's playground, BBQ facilities, picnic tables and landscaping. The park services both travellers stopping to use the amenities and local park users.

**Building description:** The traditional brick style building with tiled roof includes male and female entry points at either end of the building. The entries are behind maze style brick walls, with the building located towards the rear of the park, potentially reducing a feeling of safety for some users. There is a paved path from the road to the facility, however this is uneven in some places and could be improved. The building has open ventilation, however relies on artificial lighting.
