ATTACHMENTS EXCLUDED FROM AGENDA ORDINARY COUNCIL MEETING 27 JULY 2023

CCL23/202 Growing Regions Program Round 1 - Expressions of Interest

Dubbo Regional Council – Flood Response 2022 Priority Site Summary – Site 4 – Sandy Beach – Dubbo NSW

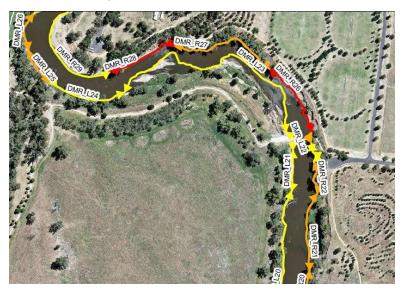
The inspection extent is located on the outside bend of the Macquarie River approximately 600m downstream of the pedestrian bridge at Lady Cutler Oval. This summary focusses on an approximate 200 m section encompassing bank section DMR_R28. The River Health Report (SCS 2018) identified the section as having severe instability with the expectation that the next major flow event would result in further substantial bank retreat.

The bank section is surrounded by parklands on both banks and is located immediately upstream of Sandy Beach, an area of high public utilisation for river access. The Macquarie River abuts the valley margin downstream of the inspection reach on the left bank.

- The options provided for this reach in the River Health Report 2018 are still applicable to mitigate further bank retreat. This included a recommendation of fencing as a minimum to restrict public access to the banks edge to mitigate safety risks. Significant bank and rehabilitation work involving bank reshaping and toe protection via up to 8 deflector structures would be required to stabilise the bank.
- 2. Realign the pedestrian access path and establish a vegetated buffer 20-30m distance from the bank retreat scarp to improve public safety. This is considered a temporary measure only as it is expected that this bank section will continue to retreat through erosion during flood events. As a result, a realigned path will likely be impacted by bank retreat in the future.
